BRIEF

Heavier Rail Cars Strain Wisconsin's Timber Bridges

This brief summarizes Project 0092-05-13, "Impact of Railcar Weight Change on Wisconsin Bridges," produced through the Wisconsin Department of Transportation Research, Development & Technology Transfer Program, 4802 Sheboygan Ave., Madison, WI 53707.

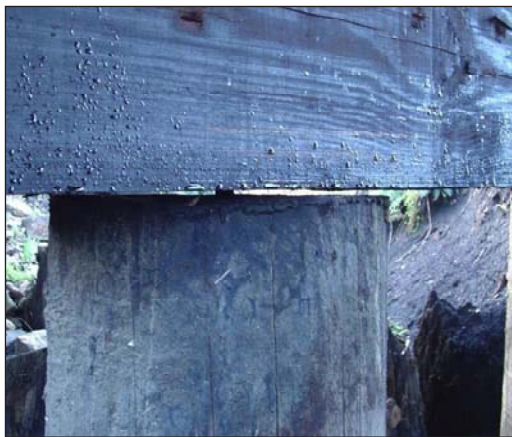
The most serious problems facing WisDOT's timber rail bridges concern piling, including pile settlement. Note the daylight showing between the pile and cap of the timber bridge at left (page 16 of the final report). In addition, beams on the timber bridges evaluated in this study frequently showed decay at the pier caps, as seen at right (page 8 of the final report).
